A NEW APPROACH TO ACOUSTIC EMISSION TESTING OF DIFFICULT-TO-REACH STEEL BRIDGE DETAILS

DAVID E. KOSNIK

Infrastructure Technology Institute / Department of Civil & Environmental Engineering
Northwestern University, Evanston, Illinois 60208, USA

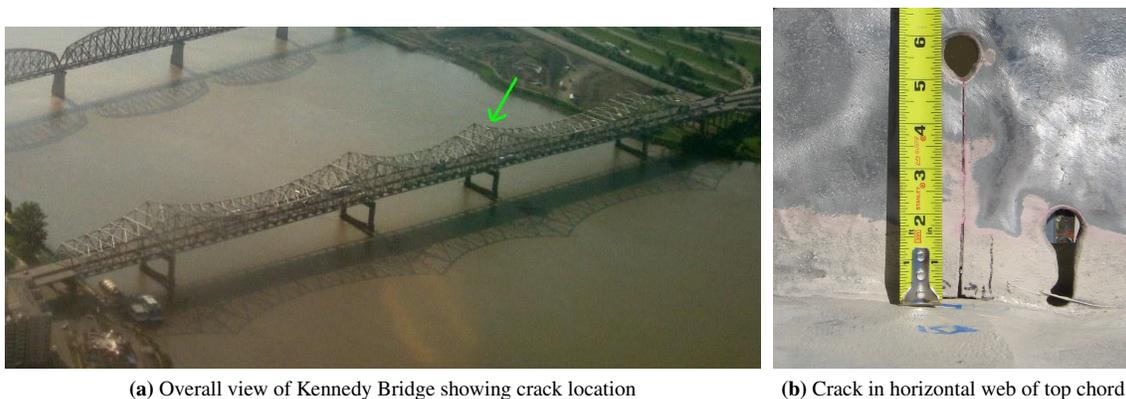
Figure 1: I-65 Kennedy Bridge

(a) Overall view of Kennedy Bridge showing crack location

(b) Crack in horizontal web of top chord

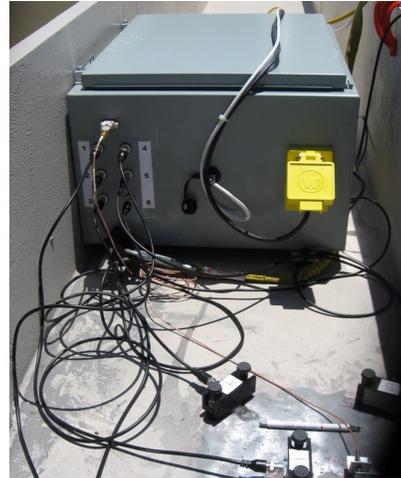
(b) AE enclosure deployed on the top chord of the Kennedy Bridge

Figure 2: Weatherproof enclosure for AE testing of difficult-to-reach details on steel bridges

These measurements were made possible by a new approach to AE testing and monitoring of large civil structures. A specialized enclosure, which could be installed at the area of interest from a bucket lift during a brief lane closure and then powered and controlled via a simple umbilical, was developed to eliminate long lead cables and exposure of AE equipment to the elements. This approach also facilitates longer-duration tests, allowing AE events to be recorded under a wider variety of traffic and other environmental conditions. The flexibility and robustness of this method promises to make AE testing of large civil structures, especially fracture-critical bridges, easier and more widely available.

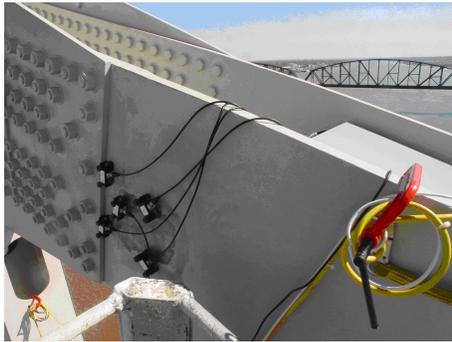
(a) Array on vertical flange

Figure 3: AE transducer arrays

The two test runs on the vertical flange yielded the low hit rates of 0 and 10 hits per minute, respectively. Consequently, there was no indication that the web crack was propagating beyond the partial-depth saw cut into the vertical flange. Due to the low hit count and complicated geometry of the detail, location and clustering analyses were not practical.
